<h1>Report</h1>	Page No	SIMIAN RISK MANAGEMENT LTD 101 Newton House Birchwood Park Birchwood Warrington WA3 6FW T/F: 0845 602 2418 E: info@simian-risk.com www.simian-risk.com

CLIENT:	Bliss Scaffolding	CONSULTANT:	Steve Trafford
SITE/DEPOT:	3 site visits	DATE OF VISIT:	18//12//2007
CONTACTS:	Keri Bliss - Dale Pinnock	REPORT TYPE:	Random Site and Scaffold inspections

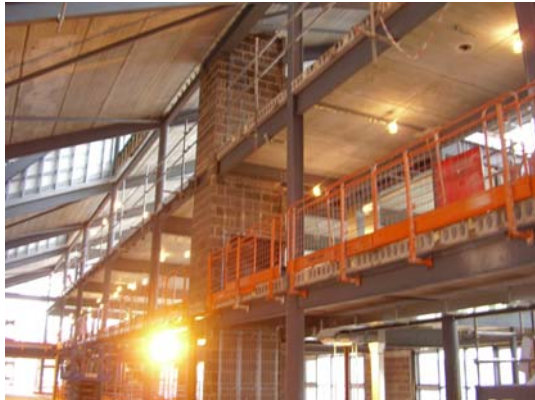
1.0	<p style="text-align: center;"><u>Warwick University CV4 7AL</u></p> <p style="text-align: center;">Scaffolders working at this location at the time of the inspection. Giles Prickett Foreman Jamie Madison PT 2 Rob Halt PT 2 Jordan Dorrel Trainee</p> <p>The site inspection took place accompanied by Jamie Madison.</p> <p>The scaffolds inspected were of a good standard and no major issues were found .</p> <p>All assessments were signed and up to date and statutory weekly inspections had been completed.</p> <p>Edge protection to floor levels was being fitted to replace the easy deck previously installed. (Fig 1)</p> <div style="display: flex; justify-content: space-around;"> <div style="text-align: center;">

<p>Fig. 1 Floor edge protection</p> </div> <div style="text-align: center;">

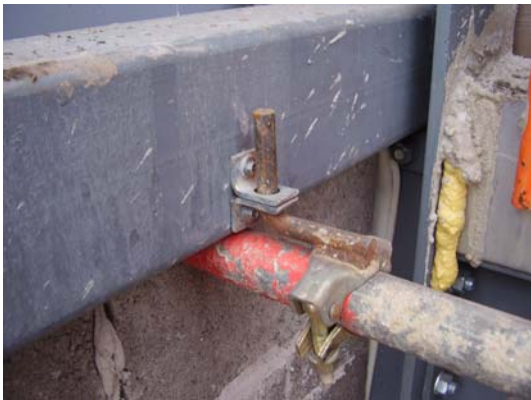
<p>Fig 2 Ties in position.</p> </div> </div> <p>The two end elevations featuring the curved scaffolding structures are part built with good ties in place. (Fig.2)</p> <p>The scaffold boards had all been cut on site and the overall fit was excellent. (Fig. 3)</p> <p>A section of edge protection required toe boarding, which was due for completion that day. (Fig.4)</p> <p>No problems were reported with interference</p> <p>The harnesses and lanyard seen were new issue and of a good standard.</p> <p>At time of visit all correct PPE was being worn.</p>

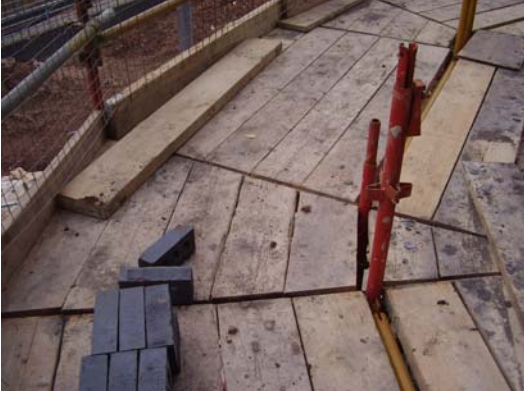
<p>Fig 3 Cut boards at curved sections</p> </div> <div style="text-align: center;">

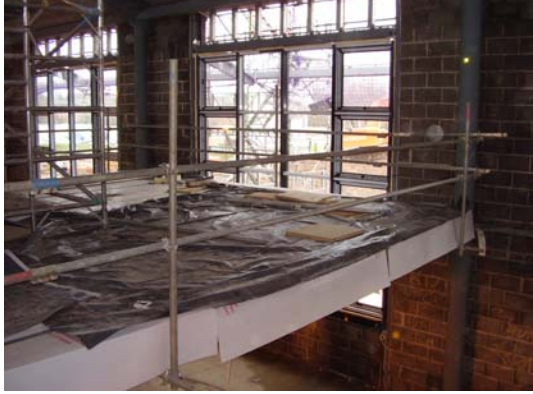
<p>Fig 4 Toe boards required</p> </div> </div> <p><i>Overall good standard as previous visits to this site.</i></p>
<p>2.0</p>	<p style="text-align: center;"><u>Northampton Girls School NN3 6DG</u></p> <p style="text-align: center;">Scaffolders working at this location at the time of the inspection.</p> <p style="text-align: center;">D Smith Foreman Richard Kitchener PT. 2 Mark Kitchener PT 2 Derek Austin Trainee</p> <p>The site inspection took place accompanied by Dean Smith the site scaffold foreman and Kevin from the bricklayers.</p> <p>In general the scaffold was of a very good standard with only minor issues found.</p> <p>While on site I observed the safe removal of stripped scaffold material from the roof via forklift. The roof area was fully protected with edge protection in place. (Fig 5)</p> <div style="display: flex; justify-content: space-around; margin-top: 20px;"> <div style="text-align: center;">

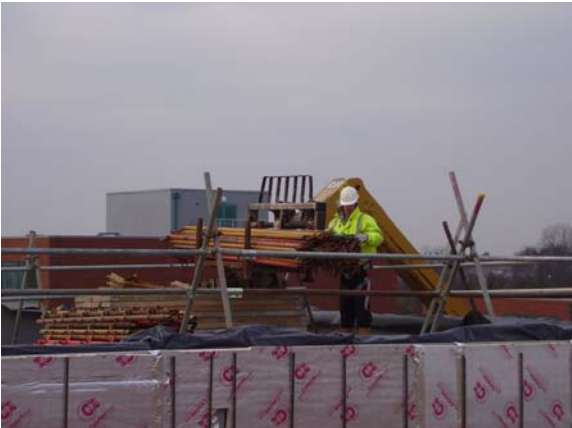
<p>Fig 5 Safe system in place for off loading</p> </div> <div style="text-align: center;">

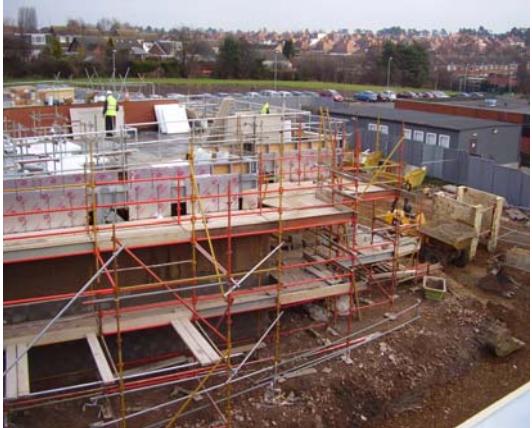
<p>Fig 6 Overview of one of the blocks.</p> </div> </div>
